Electrode Misdirection into the Superior Semicircular Canal: Complication of Cochlear Implantation by Round Window Approach

Minbum Kim, Won Sun Yang, Ju Hyun Jeon, Jae Young Choi

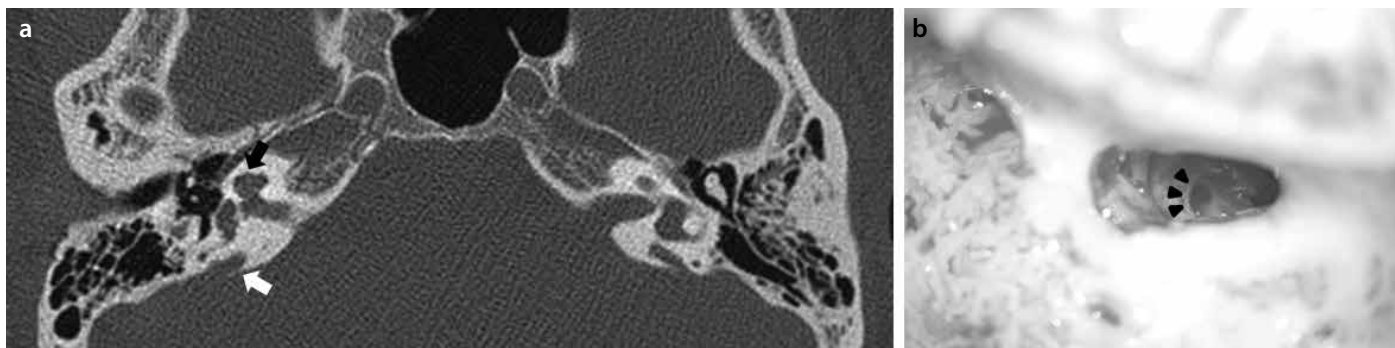
Figure 1. a, b. Temporal bone computed tomography in Case 1. Enlarged vestibular aqueducts (white arrows) with cochlea dysplasia (black arrow) are observed (a). Surgical findings in the first implantation. The round window is seen through the facial recess, but superior bony overhangs (black arrowheads) of the round window niche prevent visualization of the margin of the round window membrane (b)

Pure tone audiogram revealed hearing thresholds of 110 dB and 105 dB in the right and left ear, respectively, and an air-bone gap of approximately 40 dB was noted at frequencies lower than 1 kHz. Speech discrimination scores were 0 on both sides. She could detect only environmental sounds, which is equivalent to a CAP score of 1. However, her speech production capability was nearly normal for her age. Temporal bone computed tomography (CT) scans showed enlarged vestibular aqueducts on both sides, which could explain the conductive component seen at lower frequencies (Figure 1A). Cochlear implan-

tation (Nucleus CI24R (Cochlear, Sydney, Australia)) was performed in her right ear. After a regular mastoidectomy with posterior tympanotomy, the round window membrane was clearly defined. The electrode was inserted after membrane incision by using a sickle knife without bony drilling (Figure 1B). After implantation, she suffered from vertigo. A postoperative X-ray revealed a misdirected electrode (Figure 2A), and the tip of the electrode was found to be situated in the superior semicircular canal. In the revision surgery, bony drilling around the round window niche was performed until the margin of the round window membrane and the basilar membrane were exposed clearly. The previous electrode was reinserted in the direction from posterior-superior to anterior-inferior. Appropriate insertion of the electrode into the cochlea was confirmed by postoperative X-ray (Figure 2B). A postoperative vestibular function study showed the disappearance of cervical vestibular evoked myogenic potential (cVEMP) (Figure 3), whereas caloric responses remained unchanged. Dizziness subsided in several days with conservative management.

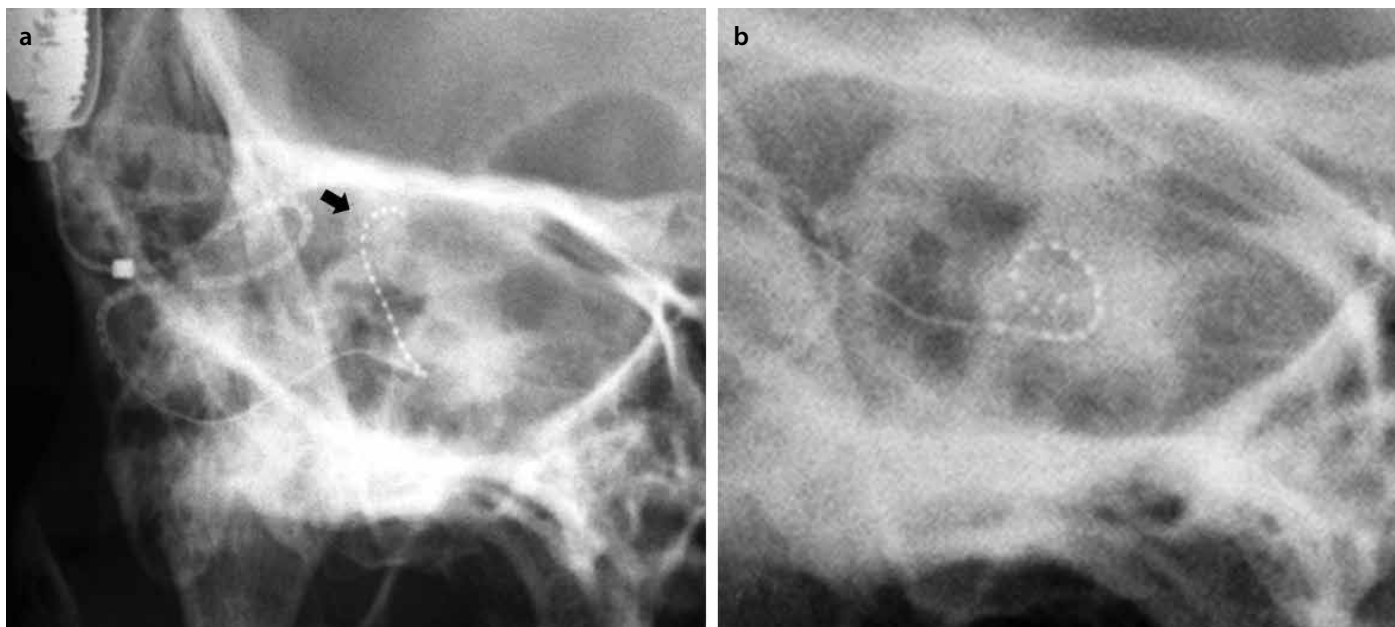
Figure 2. a, b. Modified Stenver's views in Case 1. The electrode is located in the superior semicircular canal after the first implantation (arrow) (a), and it is repositioned into the cochlea after the second operation (b)

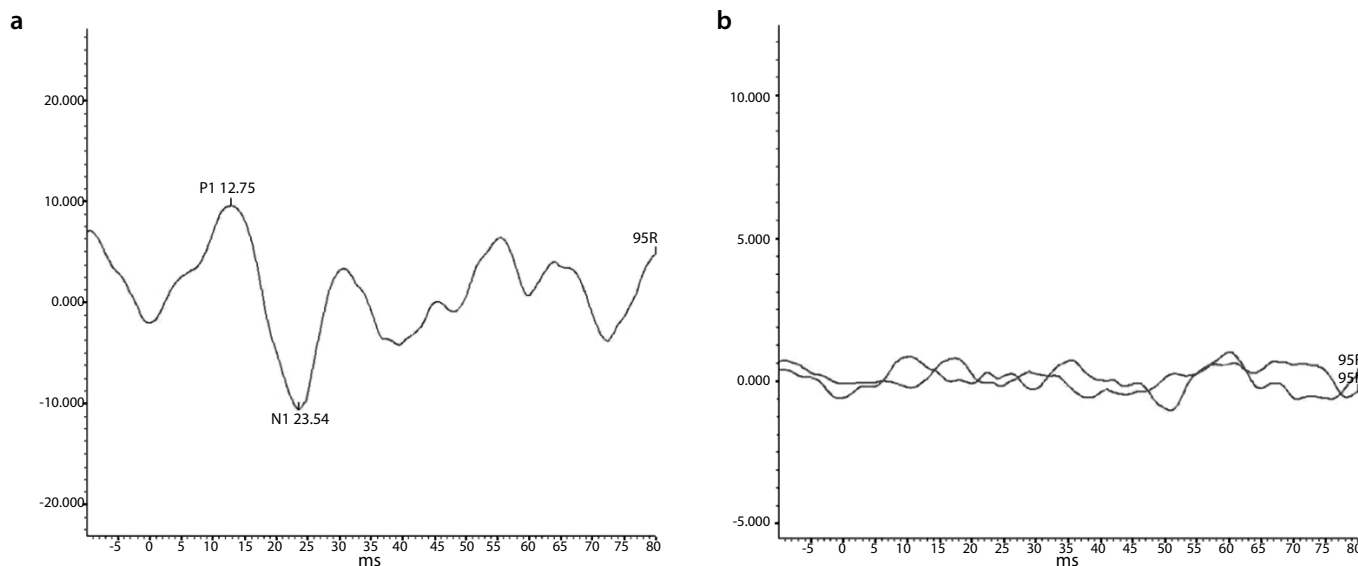
Figure 3. a, b. Preoperative (a) and postoperative (b) cervical vestibular evoked myogenic potential (VEMP) in Case 1. The VEMP response disappeared after the first cochlear implantation

superior semicircular canal, which might explain the disappearance of VEMP. The misplacement is thought to be due to the inadequate identification of the round window membrane. The round window varies in size and shape and so does its bony margin^[10,11]. Bony overhangs or intracochlear obstructive structures can result in the misguiding of the electrode toward the basilar membrane and not along the scala tympani, as in our cases. Drilling of the bony overhangs and exposing the whole round window membrane can prevent this mistake.

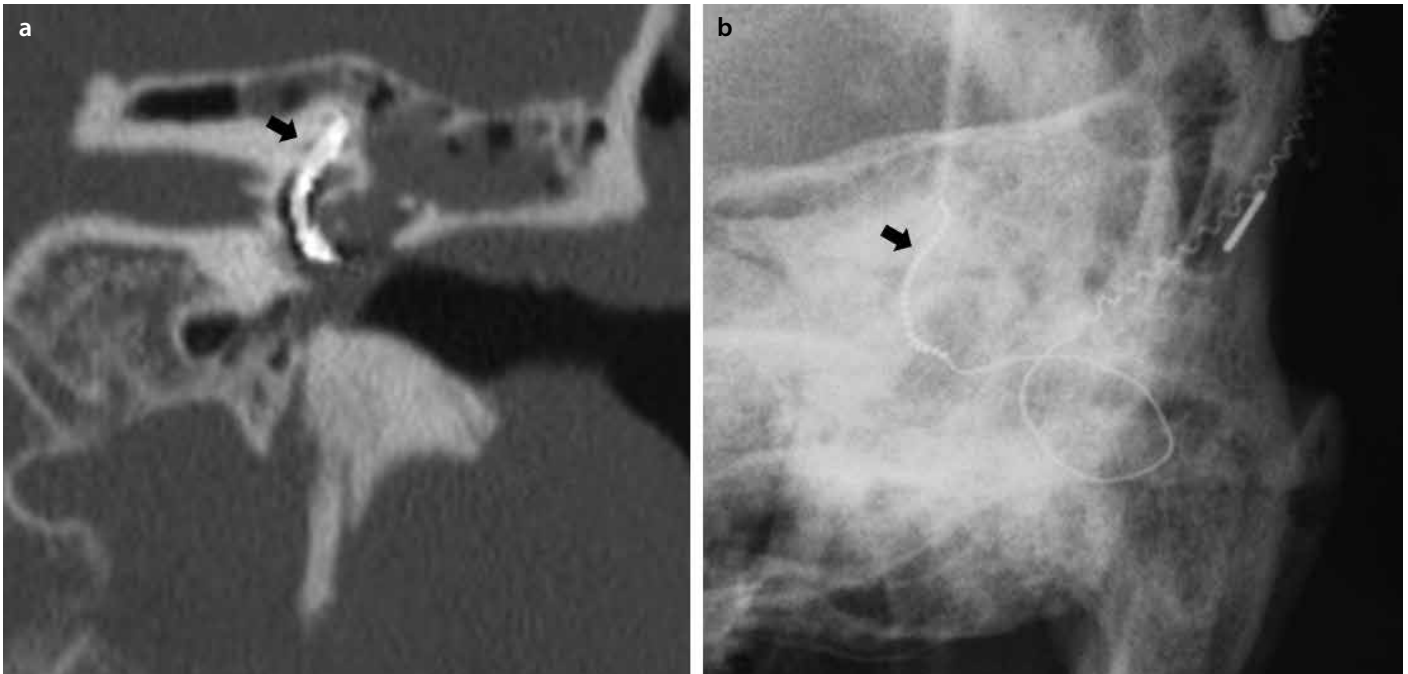
During the revision surgery, the skin flap was elevated carefully, and the internal device was removed after cutting the electrode instead of pulling it out from the cochlea. After positioning a new internal device, the previously inserted electrode was gently removed. Intracochlear soft tissue was observed. A new electrode was inserted following the path of least resistance. Postoperatively, the patient complained of neither headache nor dizziness. However, a radiographic study showed a misdirected electrode to the superior semicircular canal (Figure 4).

Figure 4. a, b. Postoperative images in Case 2. Electrode malposition in the superior semicircular canal (arrow) is observed in the coronal view of temporal bone computed tomography (a) and in the modified Stenver's view (b)

In the third surgery, an intracochlear obstruction with fibrous tissue was observed after electrode removal. Soft tissue around the round window was removed, and the electrode was reinserted after bony drilling of the posterior-superior portion of the round window niche.

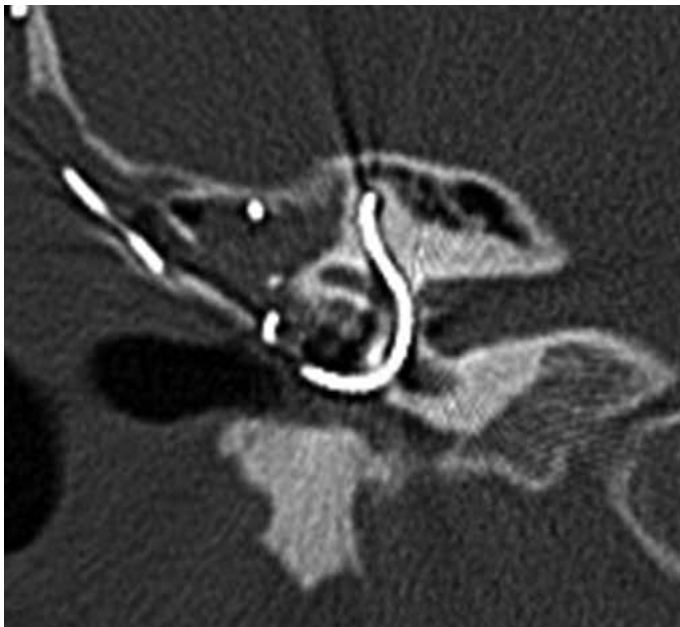
A 7-year-old female presented with prelingual deafness. She had been wearing hearing aids on both ears since the age of 2. There were no abnormal inner ear findings on the temporal bone CT. Cochlear implantation was performed with a Nucleus CI24R device (Cochlear, Sydney, Australia). The electrode was fully inserted through the round window without bony drilling. After the operation, we identified the misplaced electrode by radiograph and postoperative CT. Reinsertion of the electrode was done on the following day (Figure 5). In the revision surgery, drilling around the round window niche and identification of the margin of round window were performed antecedently for correct insertion of the electrode. The patient was discharged without any specific complications after 1 week.

Figure 5. Postoperative temporal bone computed tomography in Case 3. Electrode is inserted in the superior semicircular canal

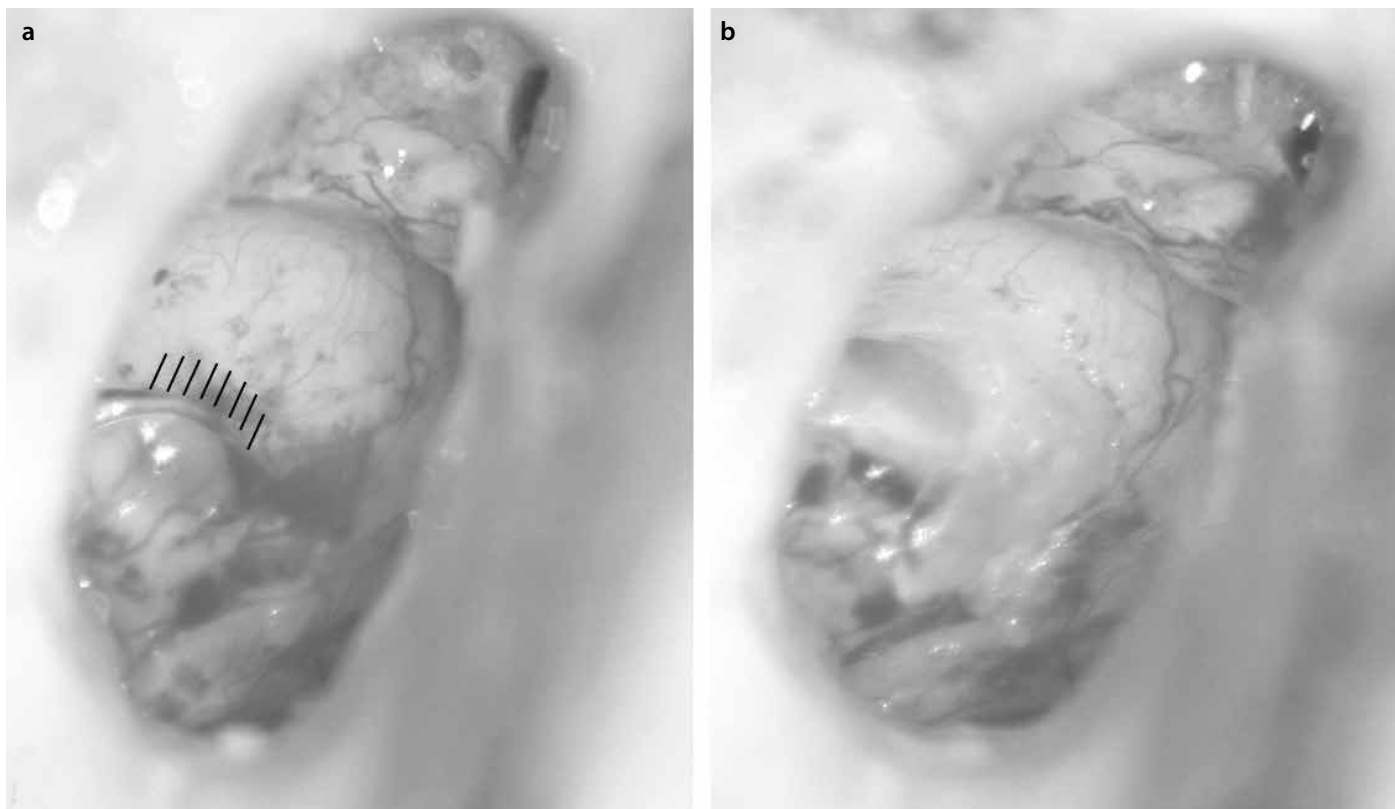
Figure 6. a, b. Exposure of the round window membrane before (a) and after (b) removing the superior and posterior bony overhangs around the round window niche (lined area)

dow membrane for correct insertion of the electrode into the scala tympani. By sufficiently drilling away the bony overhangs around the round window and removing soft tissues formed by previous implantation, surgeons can identify the exact margin of the round window and obtain an adequate insertion angle for the electrode.
